TEST REPORT No. 423810

**glass parapet named
"ALUSMART EL 51"**

**resistance to outward horizontal static loading
and resistance to dynamic impact in accordance
with standard NF P01-013:1988**

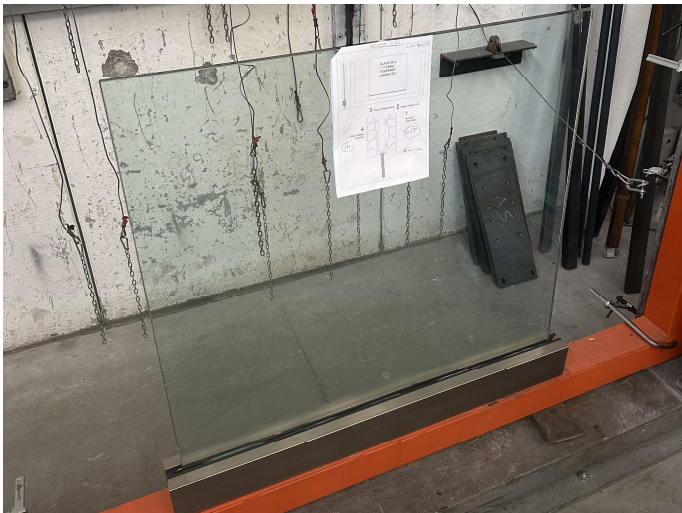
The item under examination consists of a glass parapet with aluminum structure, having the dimensional characteristics shown in the following table.

Measured overall width	1000 mm
Measured overall height from floor	1000 mm
Glass type	88.4 (PVB) tempered

Photograph of the item

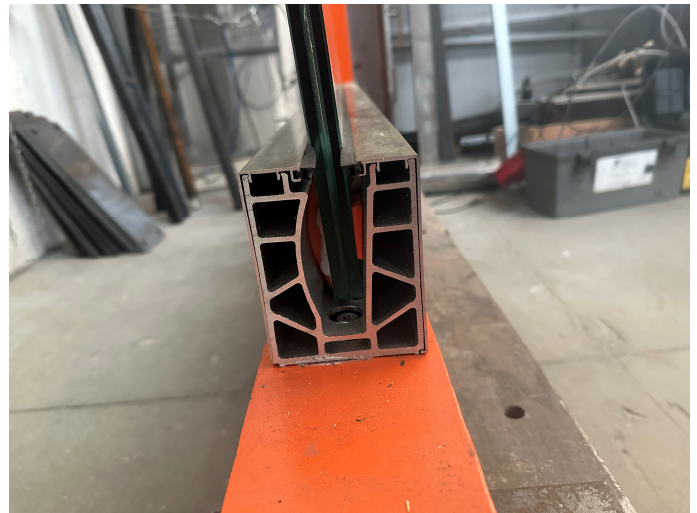
Detail

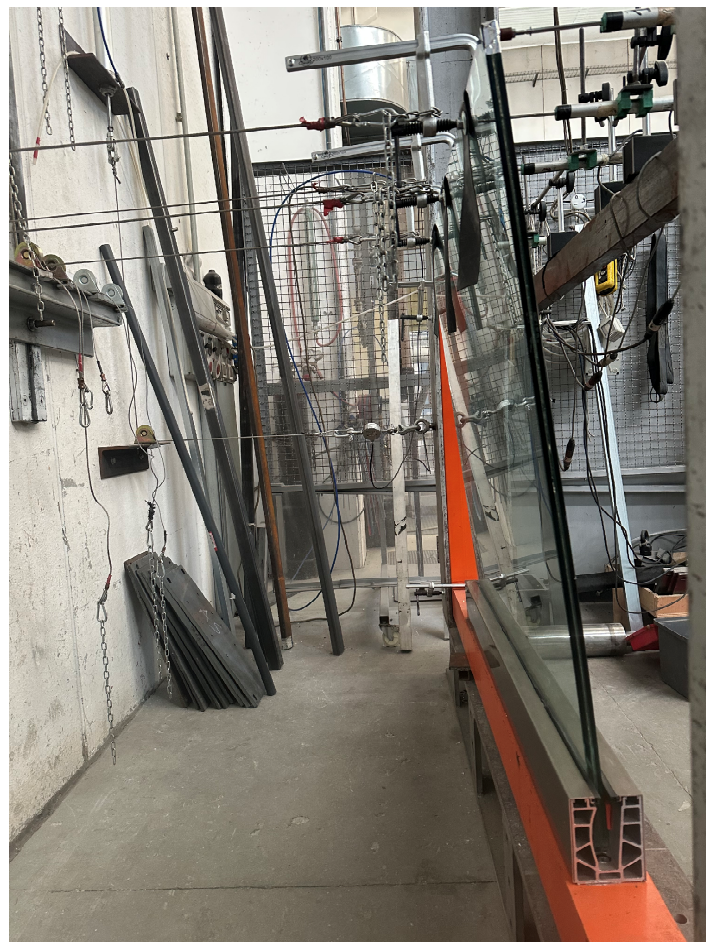
Applied load [#]	Deflection whilst loaded	Permanent deflection	Maximum permanent deflection ^{##}	Result
[kN]	[mm]	[mm]	[mm]	
1,30	59	5,4	//	//
2,21 ^{###}	110	6,3	8	pass

Photograph of the item during resistance to outward horizontal static loading test

Normative reference	Activity	Description
clause 2.2.1.2 of standard NF P01-013:1988	horizontal static loading	<p>The item was subjected to uniformly distributed load over three points, using this sequence:</p> <ul style="list-style-type: none"> – preload applied gradually until reaching the preset value and maintained for 3 min; – load removal setting the gauges back to zero; – horizontal static load applied gradually until reaching the preset value and maintained for 60 s following which deflection whilst loaded was measured; – removal of load and recording of permanent deflection after 3 min; – horizontal static safety load, with 1,7 aluminum coefficient, applied and maintained for 5 min, following which deflection whilst loaded was measured; – removal of safety load and recording of permanent deflection after 3 min; – verification of permissible permanent deflection "a", in mm, using the following equation: $a \leq \frac{8 \cdot X}{1000}$ <p>where: X = height of item from fixing point, in mm</p>

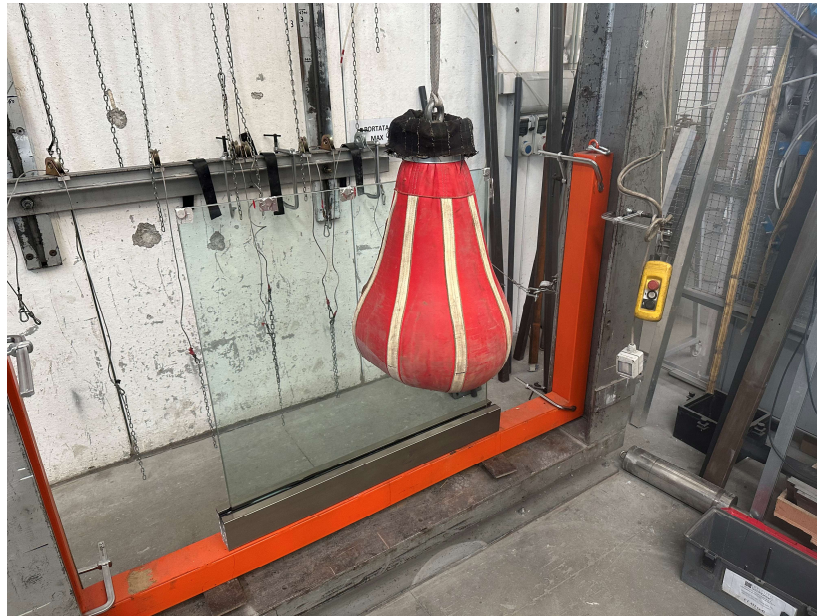
Impact area	Drop height [m]	Energy [J]	Result
centre of infill	1,2	600	no damage [#]
on the border of glass	1,2	600	no damage [#]

- (#) no falling fragments that could cause personal injury were found below.
 no gaps were formed between the bars of sufficient size to allow the passage of the gauge specified in figure 7 of standard NF P01-013:1988.
 no item performance loss compared to design specifications was witnessed.

Photograph of the item after the central impact

clause 4.5 of standard NF P08-301:1991	dynamic impact	<p>All impacts were made by releasing the impactor from a specified height with a pendulum movement and without initial velocity. The impactor was hung by an inextensible pendulum wire of negligible mass so that when at rest it made contact with the point of intended impact. After each impact, the impactor was prevented from hitting the item again after bouncing.</p> <p>Energy = 600 J (0,50 kN × 1,20 m).</p>
//	failure load	horizontal static load applied gradually until failure
